Manhole Inspection Summary

Manhole # S03GG2004MH

Insp Date: **7/11/06 12:00 AM**

Location Address: **3001 FALLSTAFF RD**

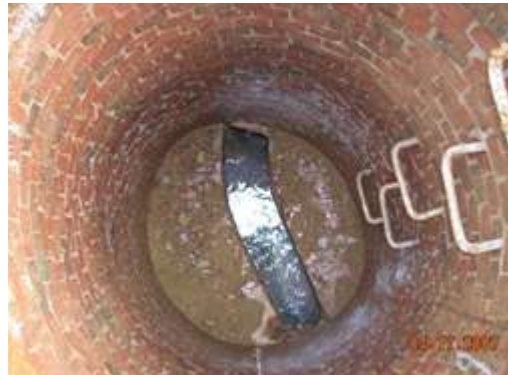
Top View

Evidence of surcharge - Bench debris.
Channel debris.

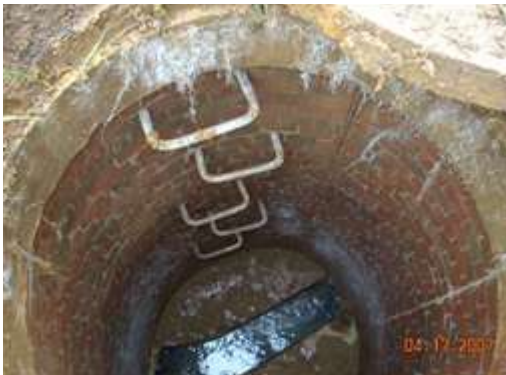
Defect

Frame leaks. Adjustment and frame root intrusion. Adjustment and Barrel infiltration - other side.

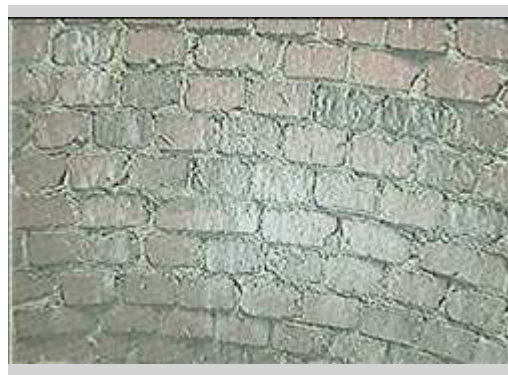
Defect

Barrel deterioration and infiltration.

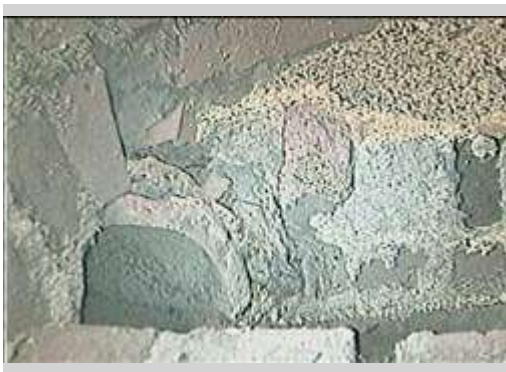
Defect

Broken and deteriorated Barrel, Bench, Channel and pipe.

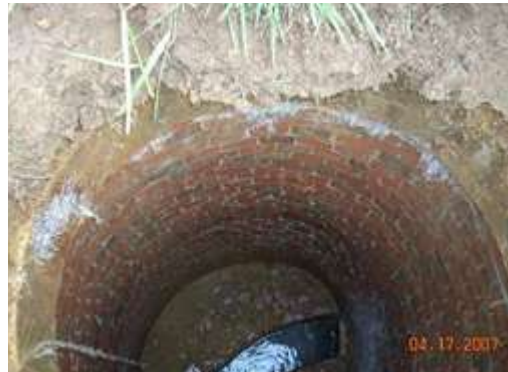
Defect

Frame leaks and root intrusion.
Adjustment root intrusion and infiltration.
Barrel infiltration.

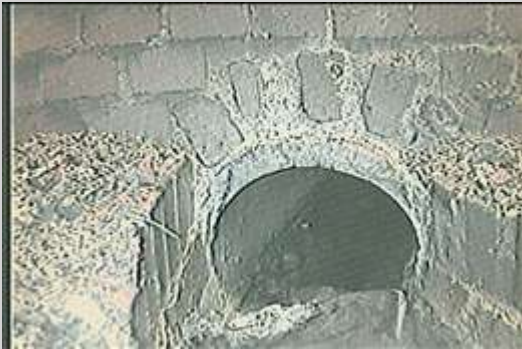
10 in. Circular Gravity Sewer Pipe Out @ 12 O'Clock

Infiltration: **Evidence** Pipe Seal Cond: **Unknown**

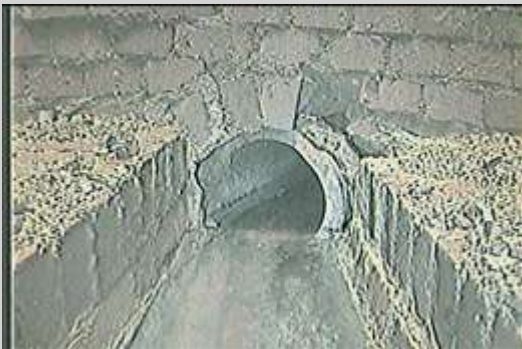
8 in. Circular Gravity Sewer Pipe In @ 5 O'Clock

Channel deterioration.

Infiltration: **Evidence** Pipe Seal Cond: **Broken**
